NetClock 9400 Series  
System Software  
Version 5.8.6

Upgrade Instructions

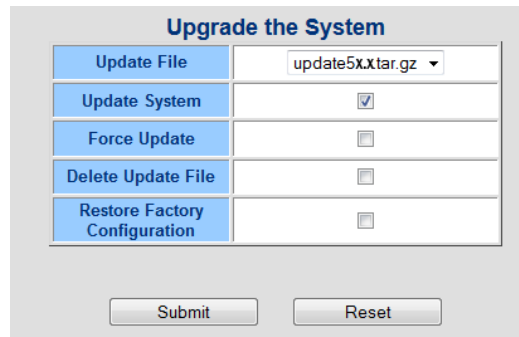
8. Now refer to the bottom of this page, under the title **Upgrade the System**. Ensure the correct file name (updateXXX.tar.gz) is selected in the box next to **Update File**.

Upgrade the System	
Update File	update5x.tar.gz ▼
Update System	<input checked="" type="checkbox"/>
Force Update	<input type="checkbox"/>
Delete Update File	<input type="checkbox"/>
Restore Factory Configuration	<input type="checkbox"/>
