SecureSync®
System Software
Version 5.8.6

Upgrade Instructions

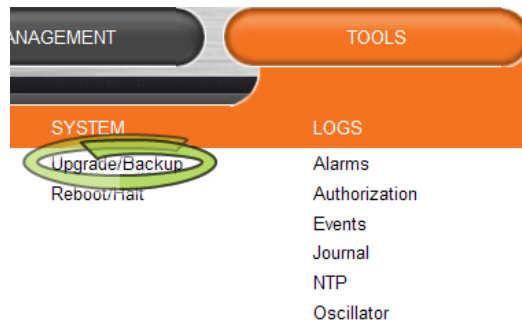
1. In the SecureSync Web User Interface (Web UI), navigate to **Tools > System: Upgrade/Backup**.

2. Take note of the system software version number.

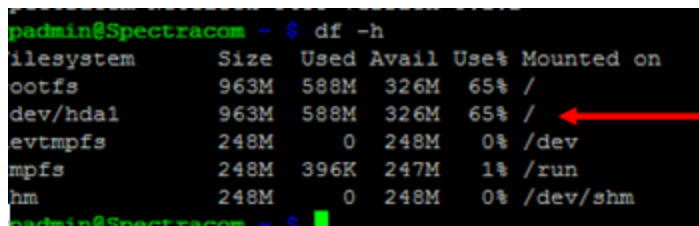
Login to the CLI (telnet or ssh) and at the command prompt, type: `df -h <enter>` (as shown below). The "Use%" column in the "/dev/hda1" row will indicate the CF card usage (65 % in this example, which indicates the logs and any previous Update files do not need to be deleted before performing the update process.)

padmain@Spectracom ~ $ df -h
filesystem      Size  Used Avail Use% Mounted on
rootfs          963M  588M  326M  65% /
dev/hda1        963M  588M  326M  65% /
devtmpfs        248M    0  248M   0% /dev
tmpfs           248M  396K  247M   1% /run
shm             248M    0  248M   0% /dev/shm

If the disk usage is higher than 70% (approximately), Spectracom recommends that you delete the **logs** and **update files** that may have been previously applied before performing the system software upgrade.
